# INSPECTION REPORT

For the Property at:  
**50 ANY ROAD**  
SASKATOON, SK

Prepared for: AN OTHER  
Inspection Date: Thursday, May 21, 2009  
Prepared by: Chris Herrington

RE: Report No. 1003

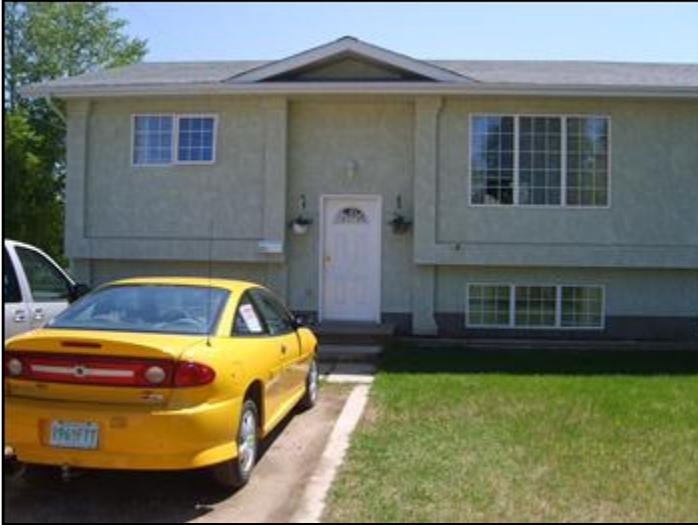
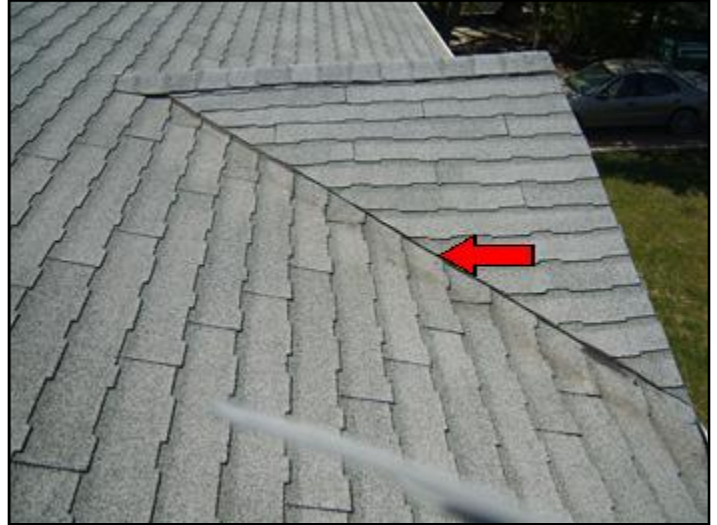
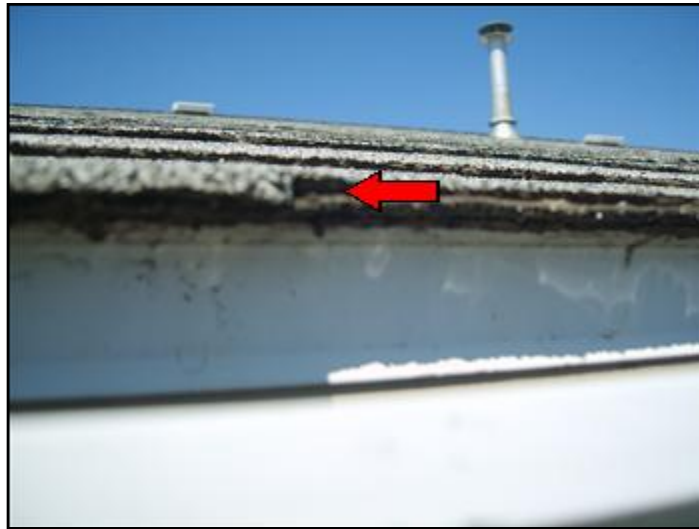
*Note:* No evidence of leakage but the valley needs to be resealed with ash felt cement to prevent water leakage in the future

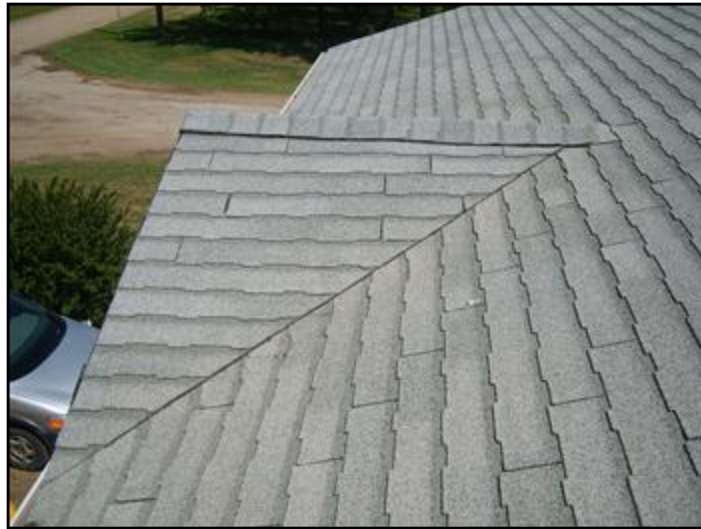
4.

*Note:* The house was built in 1995 and I found no evidence of repairs or leaks so the roof is probably original. A typical life expectancy is around 20-25 years from installation

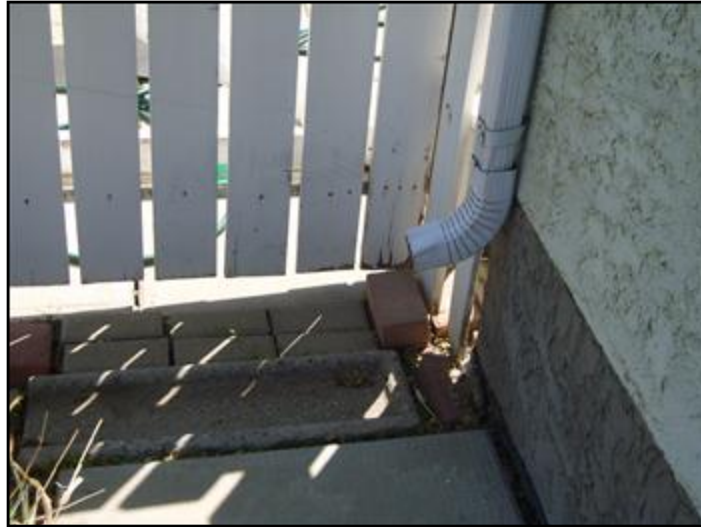
5.

Note: The downspout's discharge very close to the house foundations. I recommend a 6ft extensions to carry water away from the house foundations

**Condition:** • Should discharge 6ft. from home

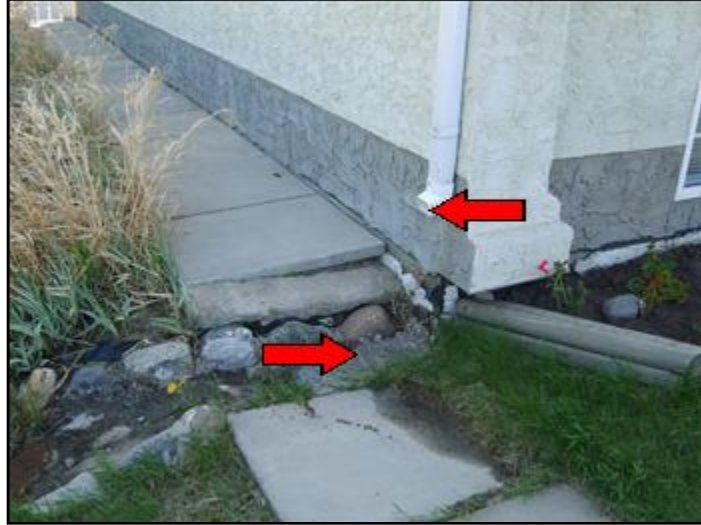
7.

Note: Some re grading all around the house to ensure water is drained away from the house

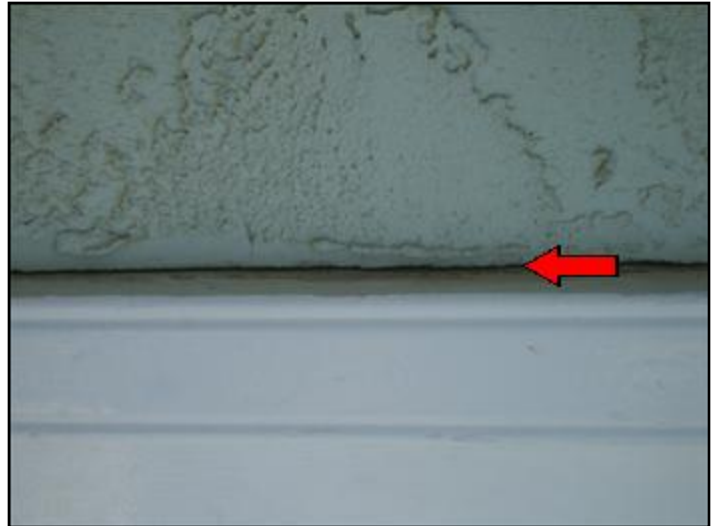
9. add new caulking

**Condition:** • [Caulking missing, deteriorated or loose](#)

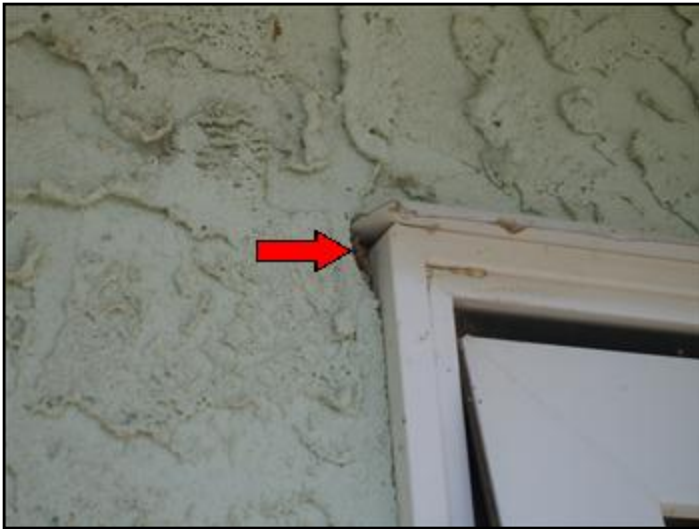
10. repair

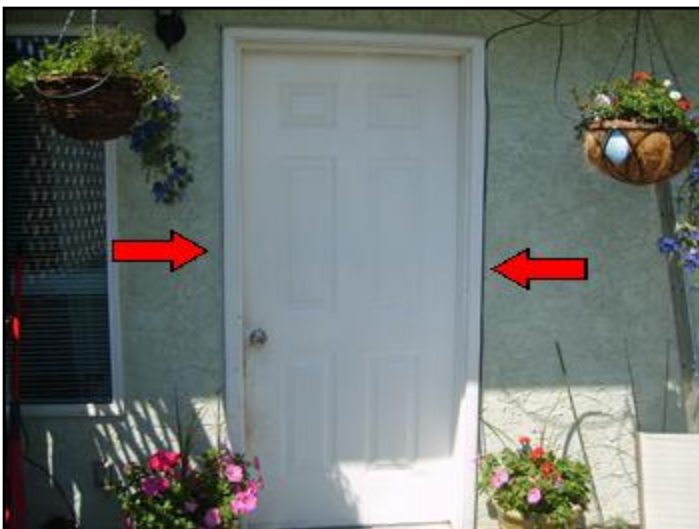
12. add new caulking

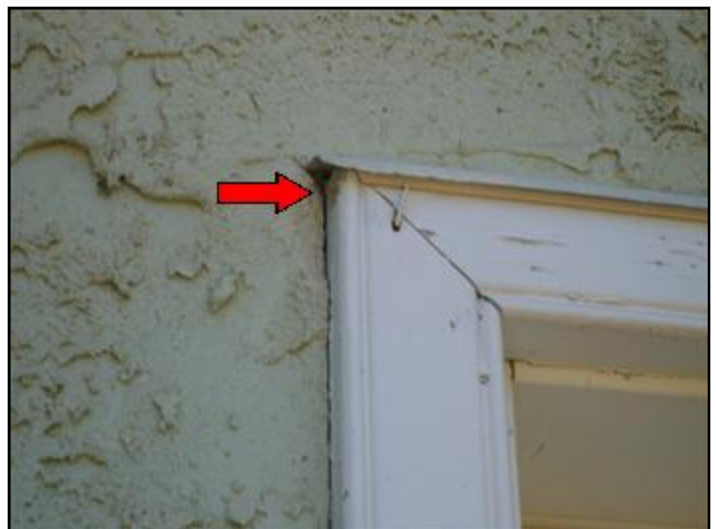
13. repair

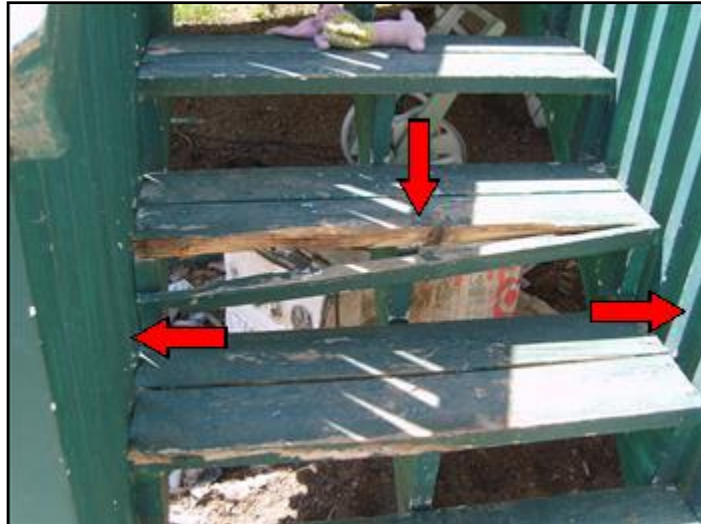
14.

*Note:* The deck is in need of attention and the steps are a trip hazard and a safety concern. It recommend that replace of re fasten the effected parts immediately

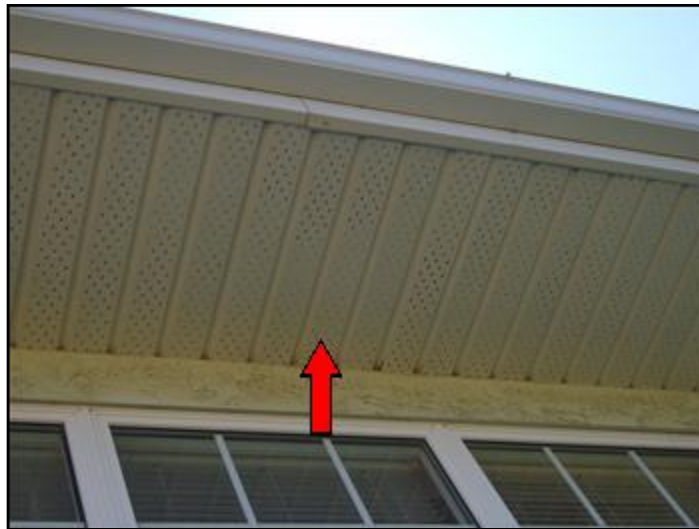
23.

*Note:* visual inspection from outside as no access to the attic space

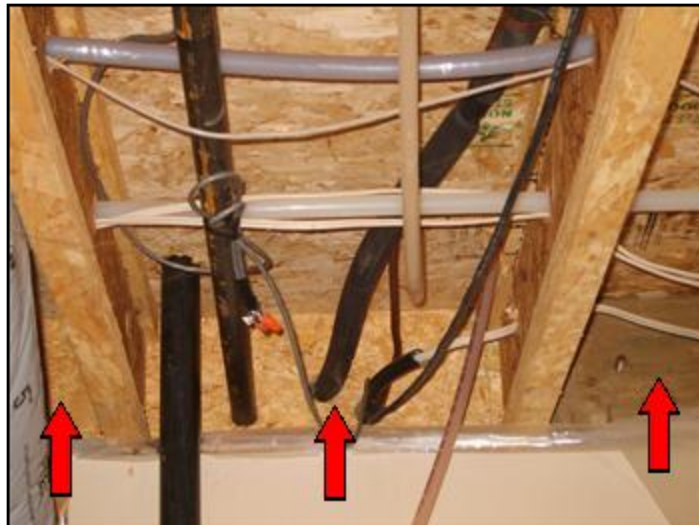
24.

*Note:* Add insulation in laundry room

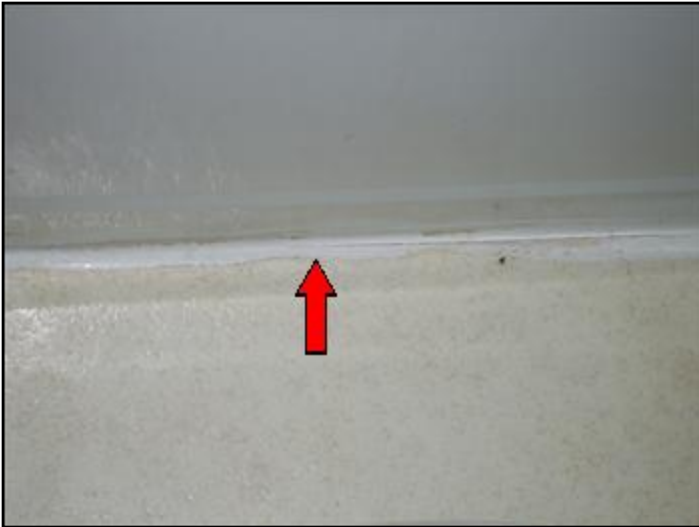
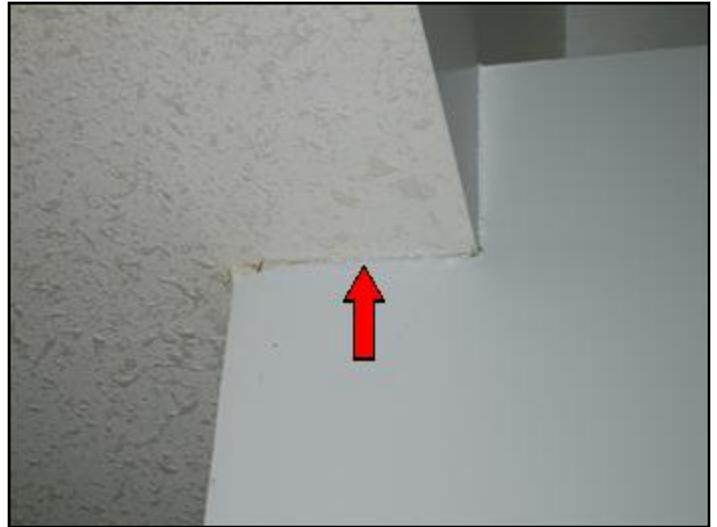
*Note: All the cracks on the main floor appear to be related to truss heave*

28. On the main floor
